**PRELIMINARY ASSESSMENT/  
VISUAL SITE INSPECTION**

**SDC SERVICES, INC.  
CORPUS CHRISTI, TEXAS  
TXD030923361**

**U.S. ENVIRONMENTAL PROTECTION AGENCY  
Region 6  
1455 Ross Avenue  
Dallas, TX 75202**

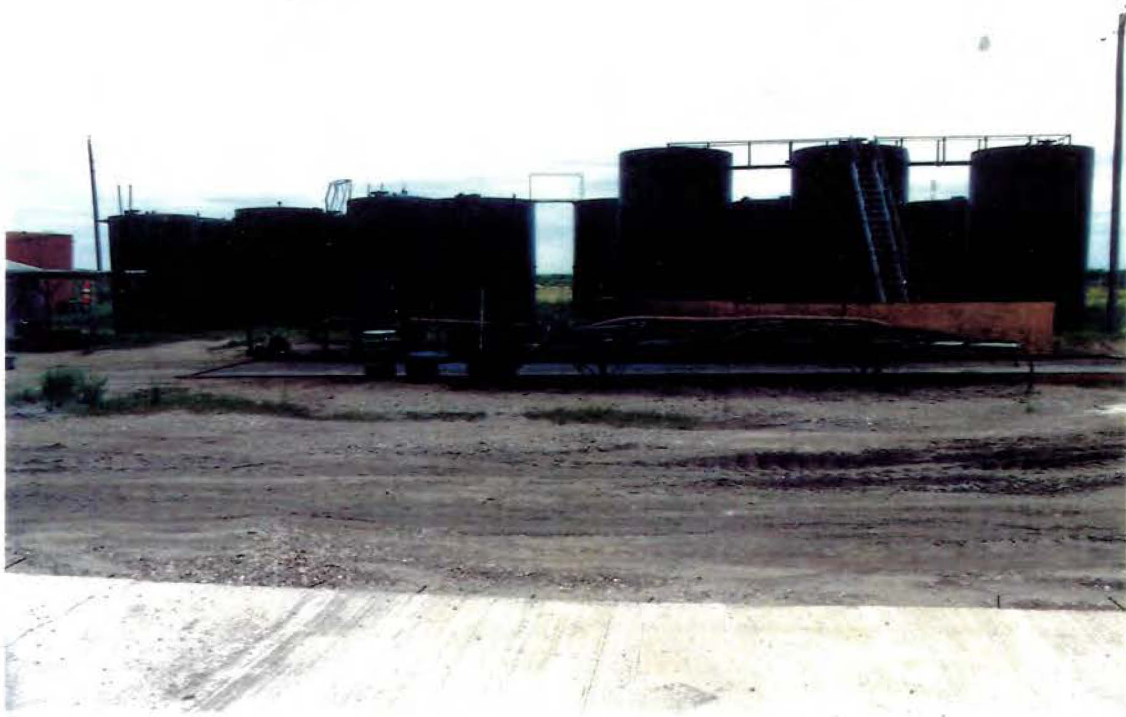
Photograph No. 1

Description: From paved area in facility center, looking at north side of SWMU No. 2; note the plywood splash wall and hydrocarbon stains; the brown tank to the left is SWMU No. 6.

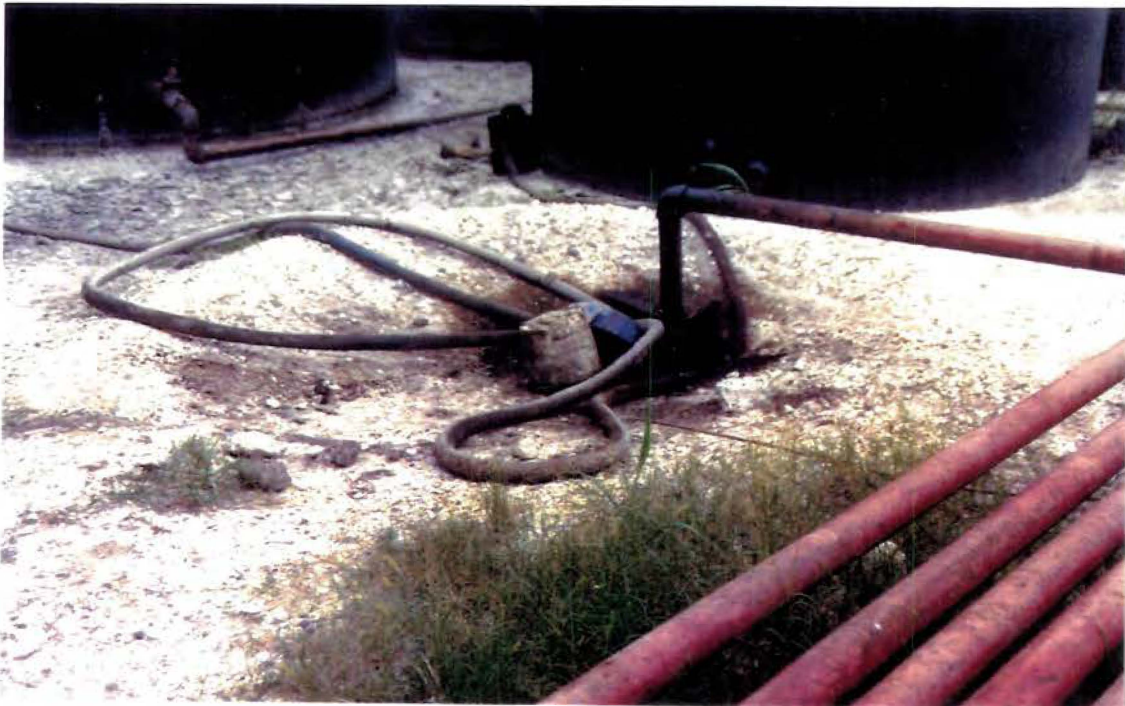
Photograph No. 2

Description: View of rectangular opening of the UST and miscellaneous hoses in SWMU No. 1; note bare soil and hydrocarbon stain

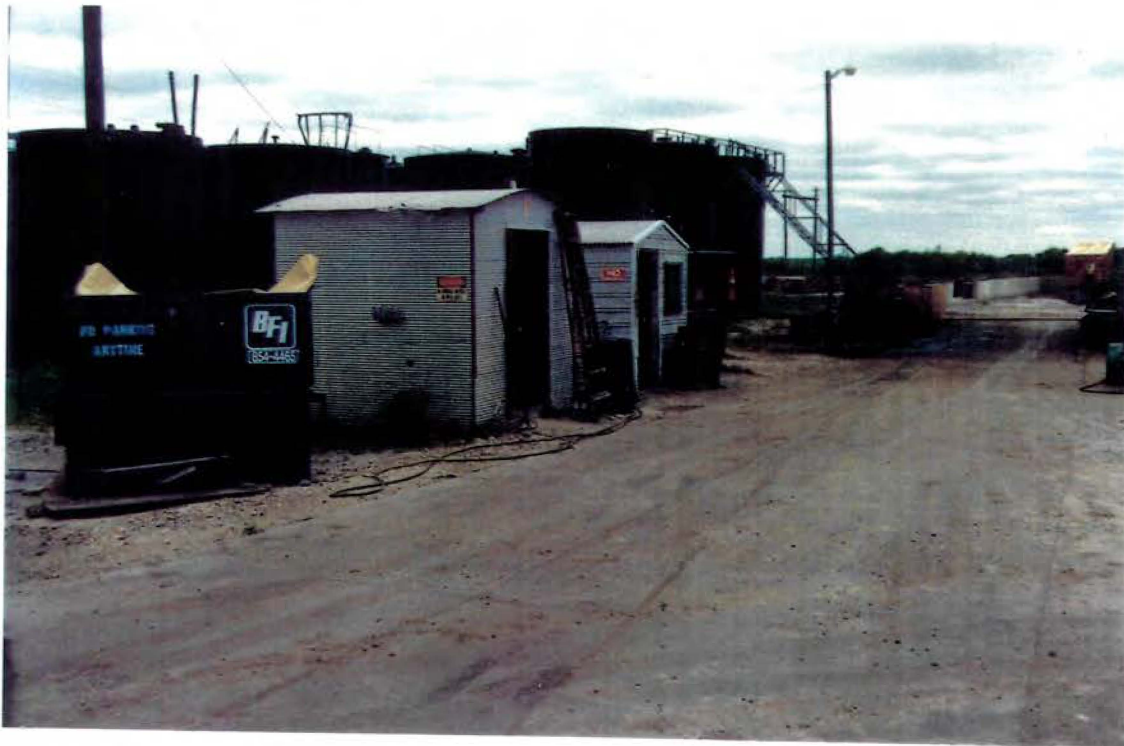
Photograph No. 3

Description: View of SWMU No. 1 from the paved truck access, with the 12 storage tanks in the background, and a laboratory and storage shed in the foreground

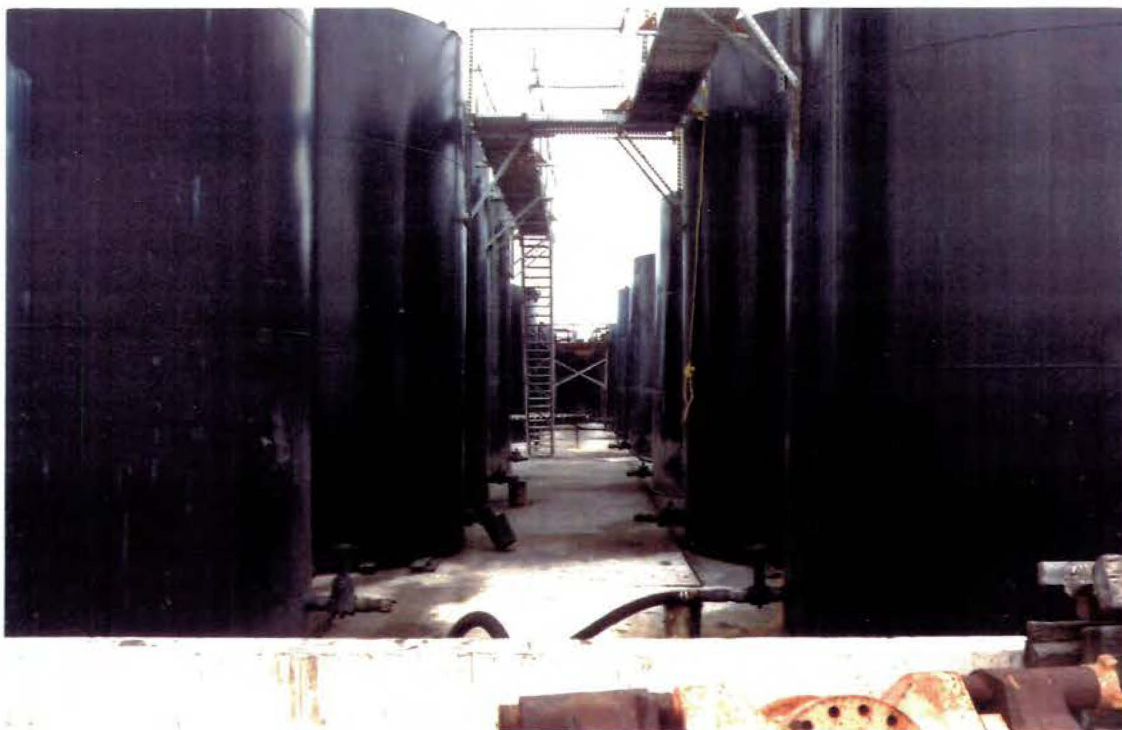
Photograph No. 4

Description: East side of SWMU No. 3 looking down center of vertical tanks; note the concrete pad in process area, and oil stains

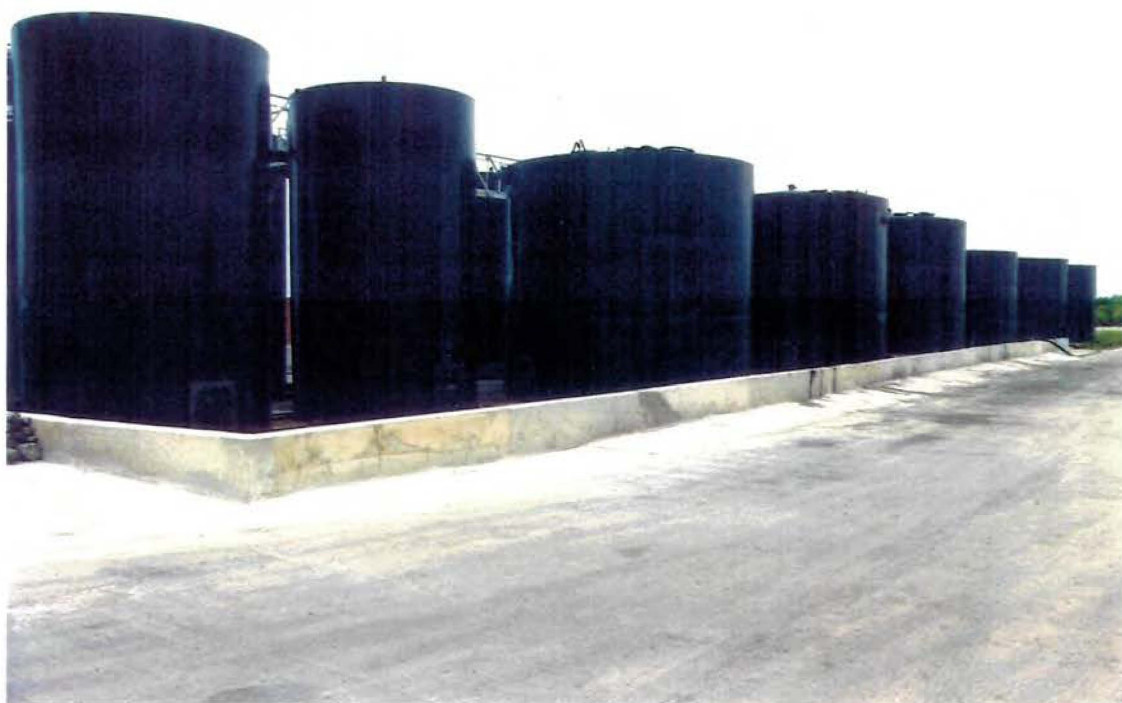
Photograph No. 5

Description: North side of SWMU No. 3 showing north row of process tanks, exposed soil at the west end, the retaining wall, and the paved truck access

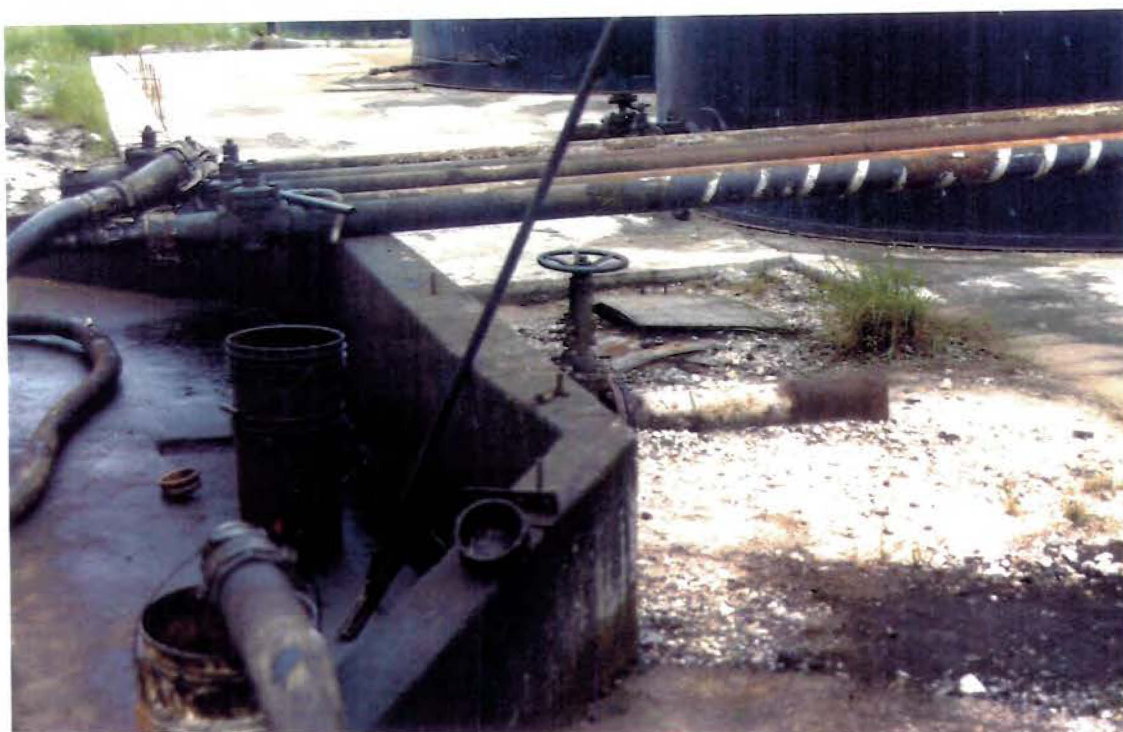
Photograph No. 6

Description: Splash wall at SWMU No. 4; note exposed soil, hydrocarbon stains, and the rectangular covered opening of the UST in SWMU No. 3

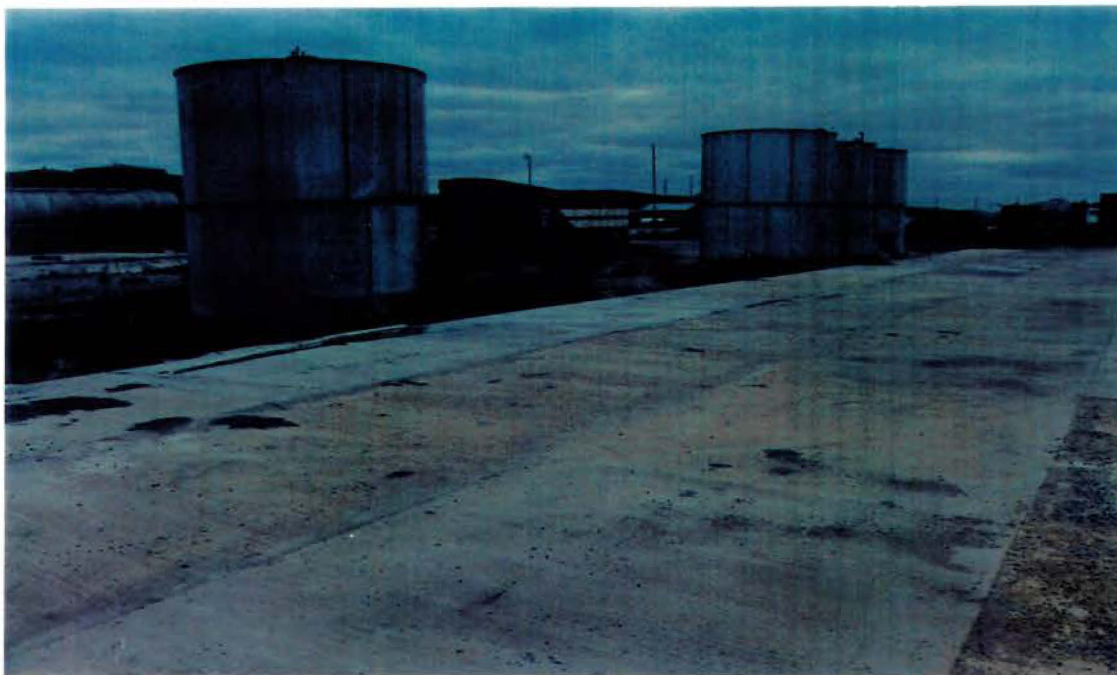
Photograph No. 7

Description: This panoramic view is east across paved area in facility center, with frac tank 1 (SWMU No. 5) in background, and tanks 5A, 5B, 5C, and 5D (SWMU No. 7) in the foreground

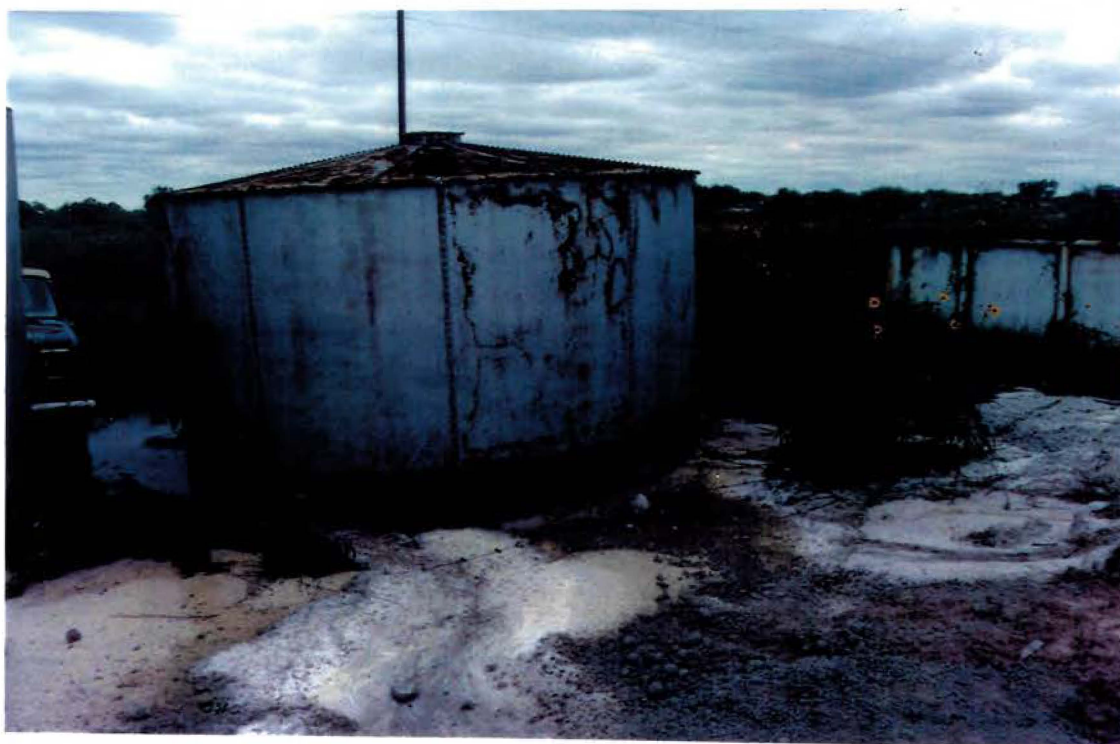
Photograph No. 8

Description: View is northwest toward Vollo Creek with tank 19 (SWMU No. 7) in foreground and skid tank 3 (SWMU No. 9) to the right

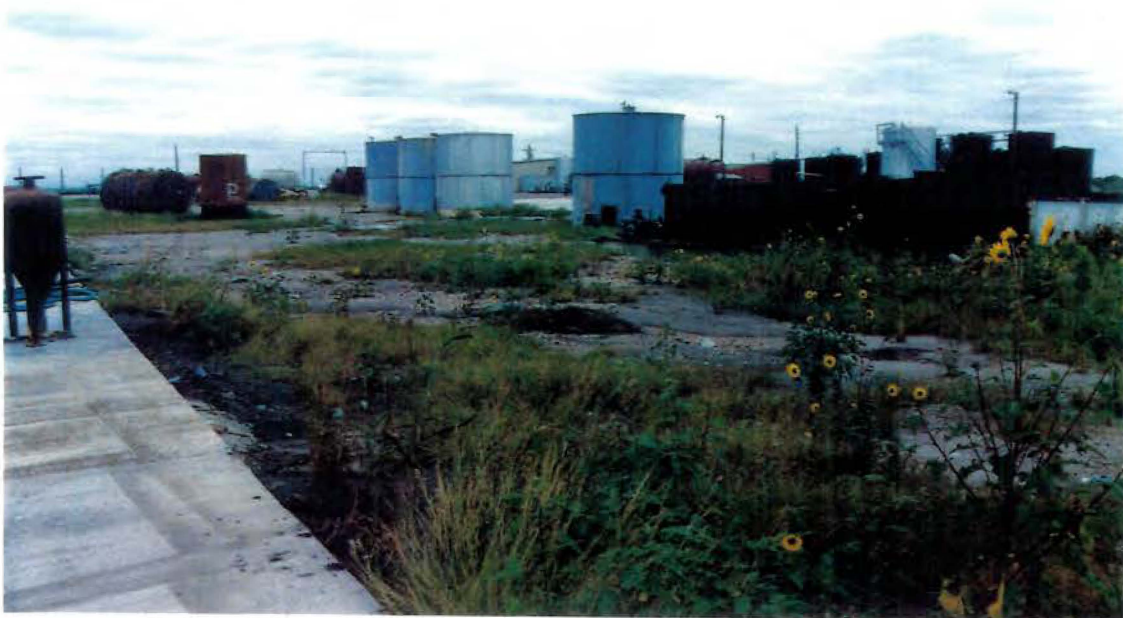
Photograph No. 9

Description: View down the center of SDC facility across SWMU No. 12 toward southeast; Tank 16 (SWMU No. 8) is the horizontal tank on the left; the silver vertical tanks are part of SWMU No. 7. Skid tanks 2 and 3 (SWMU No. 9) are seen on the right side.

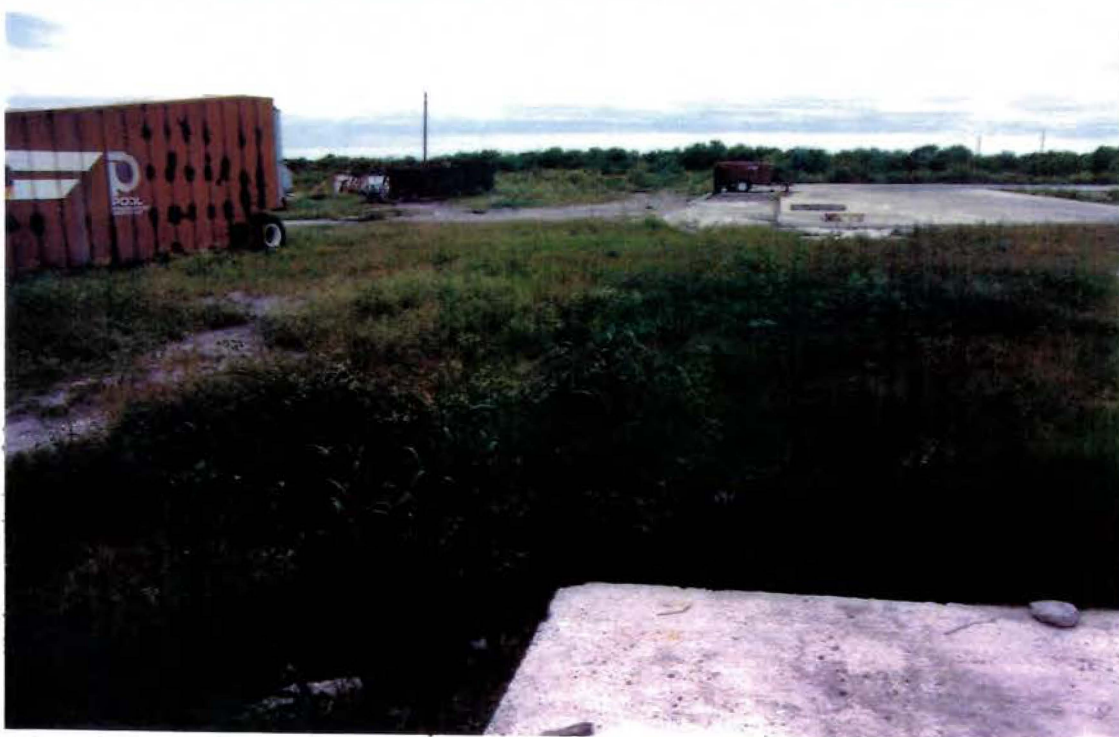
Photograph No. 10

Description: Chromium-contaminated area in the center of west end of the facility; portable frac tank 1 (SWMU No. 5) is on the left side, and skid tanks 2 and 3 (SWMU No. 9) are in the background.

PRC recommends an SI and removal action for the chromium-contaminated soil area (SWMU 12). The chromium waste is located in an open area in the center of the west end of the facility and represents an immediate threat to SDC employees through direct contact with the contaminated soil. Secondary targets are wetlands affected by surface runoff to Vollo Creek and, subsequently, to Oso Creek.

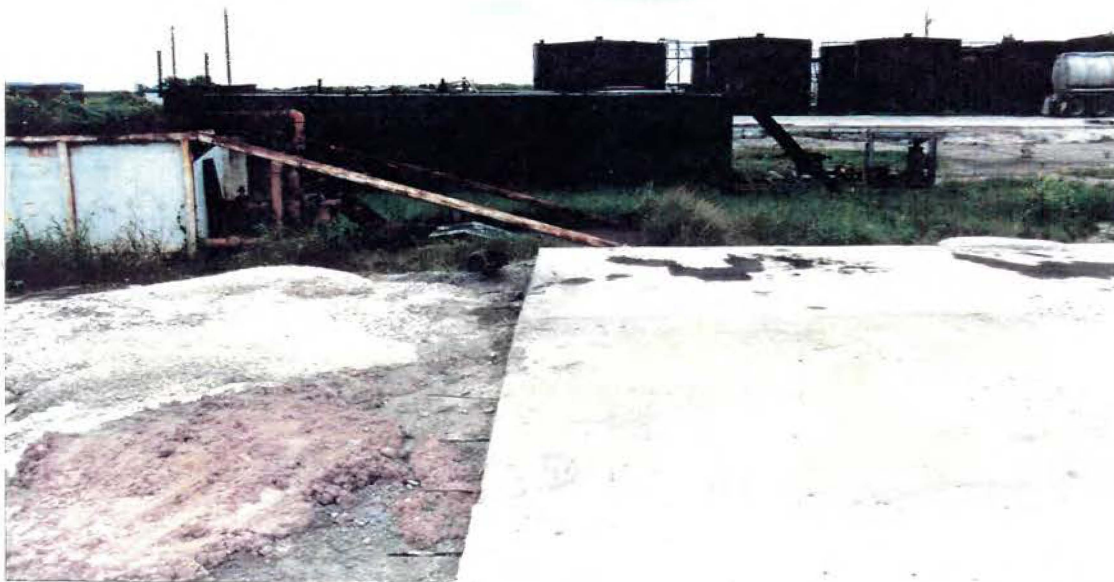
Photograph No. 11

Description: View is north across skid tanks 2 and 3 (SWMU No. 9) toward the north blending unit (SWMU No. 3), and tank storage area

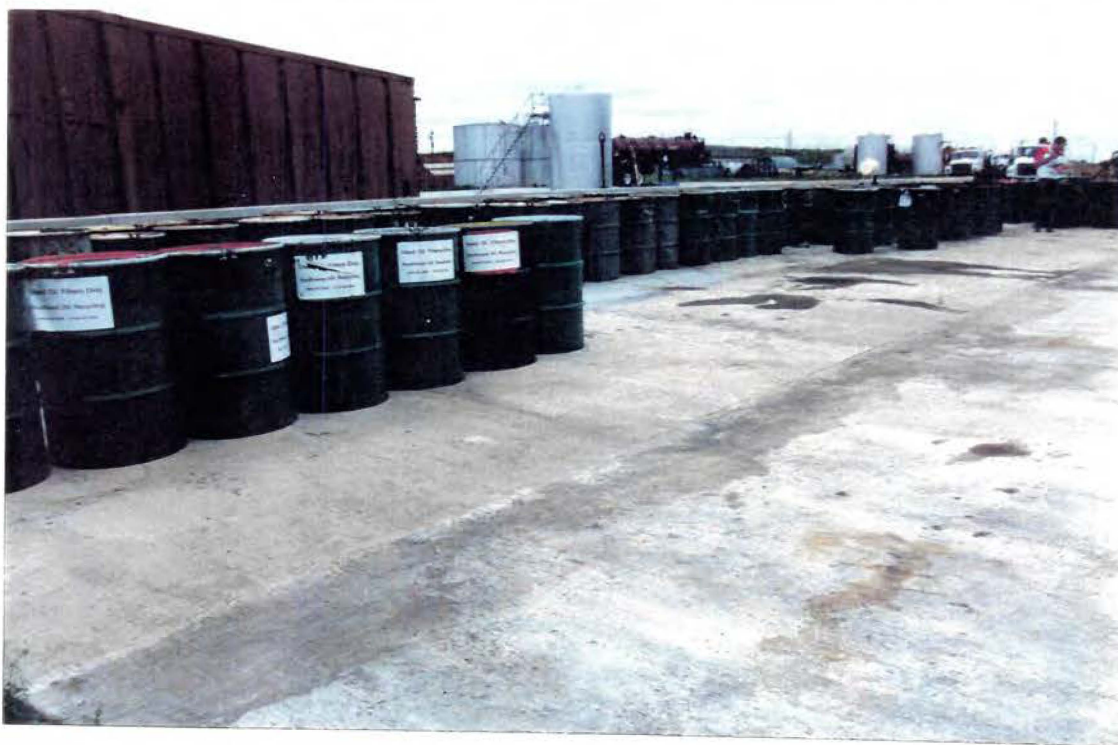
Photograph No. 12

Description: Sealed 55-gallon drums of nonhazardous waste at SWMU No. 10; frac tank 4 (SWMU No. 5) is to the left, and CalSite-1 silver tank with stairway is in background.

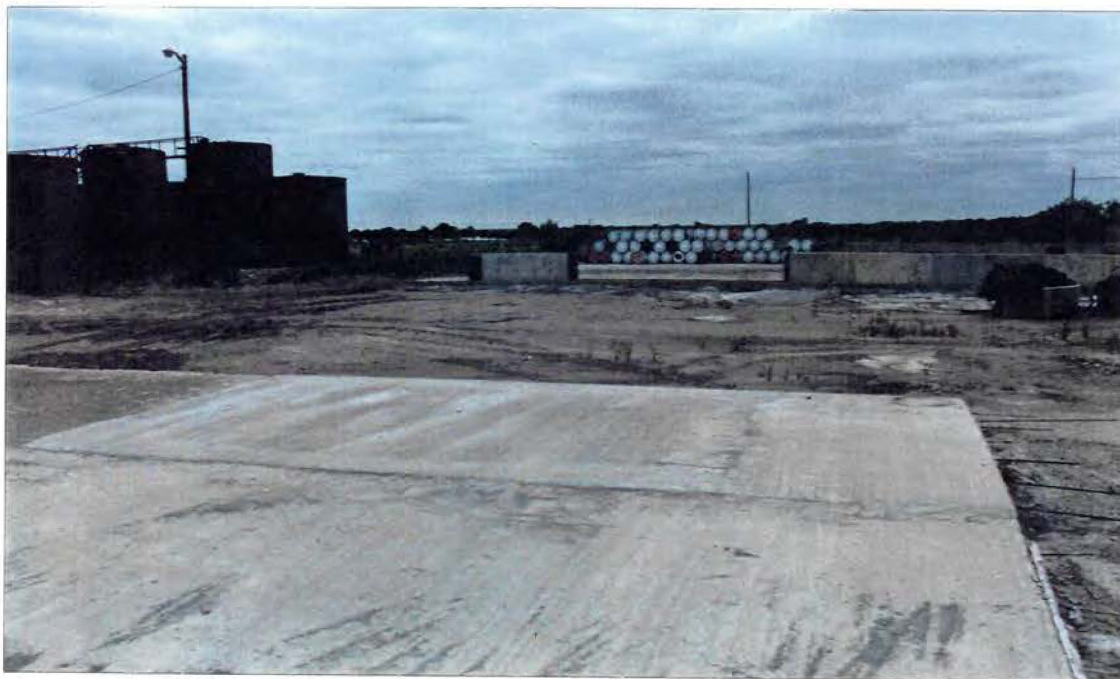
Photograph No. 13

Description: View is to the south across the container storage area (SWMU No.10), with south blending unit (SWMU No. 1) to the left

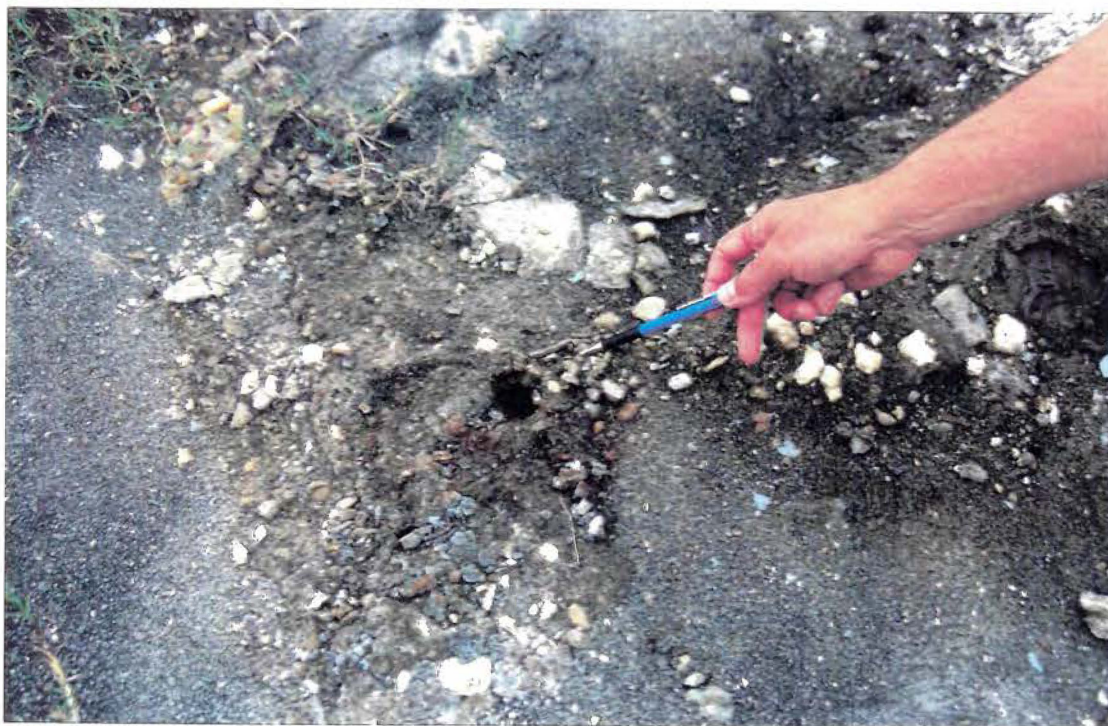
Photograph No. 14

Description: Green waste containing elevated levels of chromium, taken from the edge of pavement of south side of the north blending unit

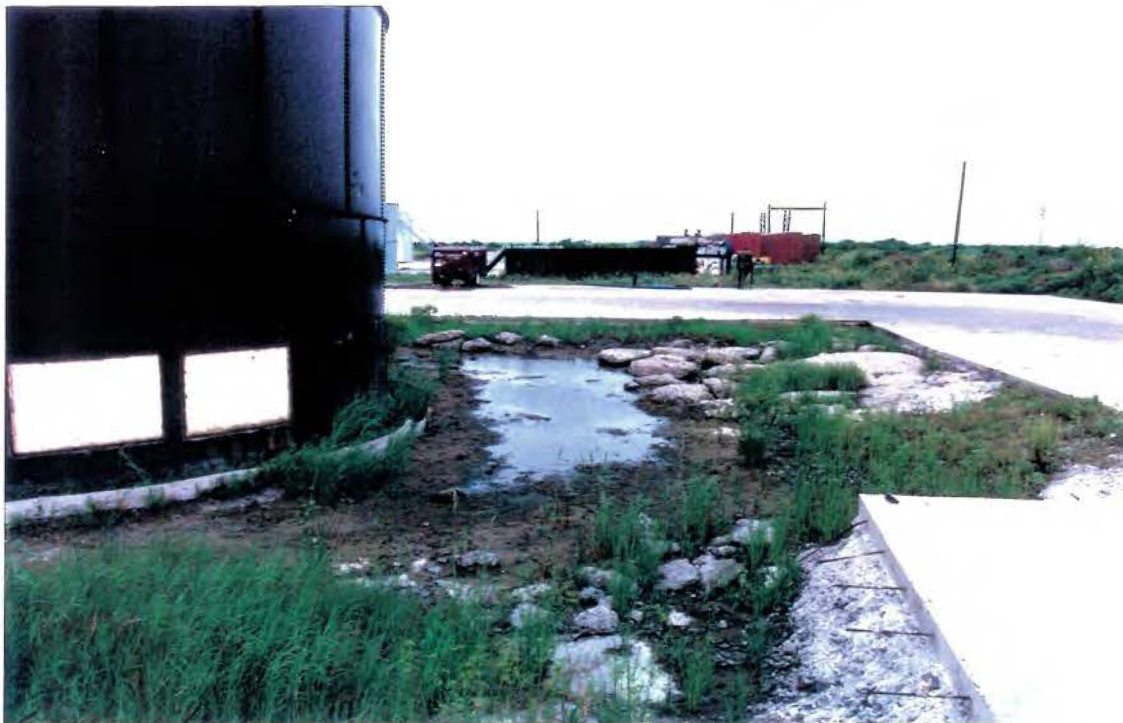
Photograph No. 15 Date: 05\29\92  
 Orientation: Southeast Location: SWMU No. 13  
 Description: Exposed soil at the west end of SWMU No. 13, with standing rainwater adjacent to Tank 2000; skid tank 2 is in the immediate background.

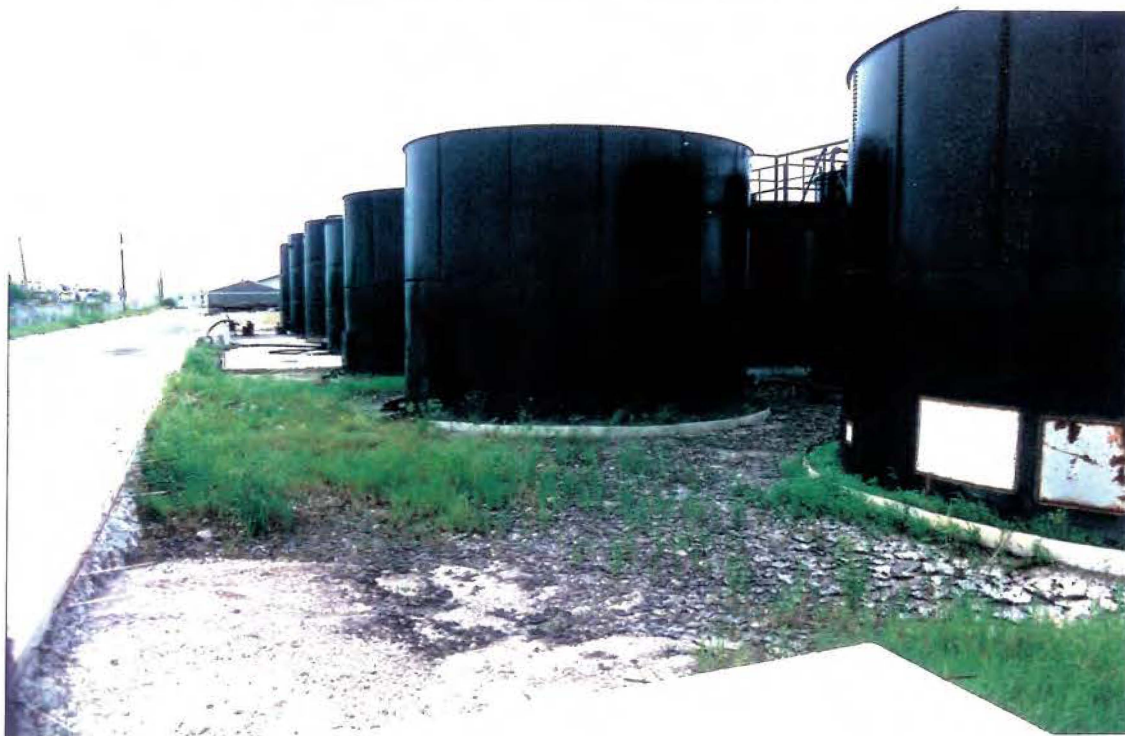
Photograph No. 16 Date: 05\29\92  
 Orientation: Southeast Location: AOC No. 1  
 Description: View of the exposed soil at the west end of AOC No. 1 with tank 2000 (SWMU No. 13) in foreground; note oil spills around the tanks

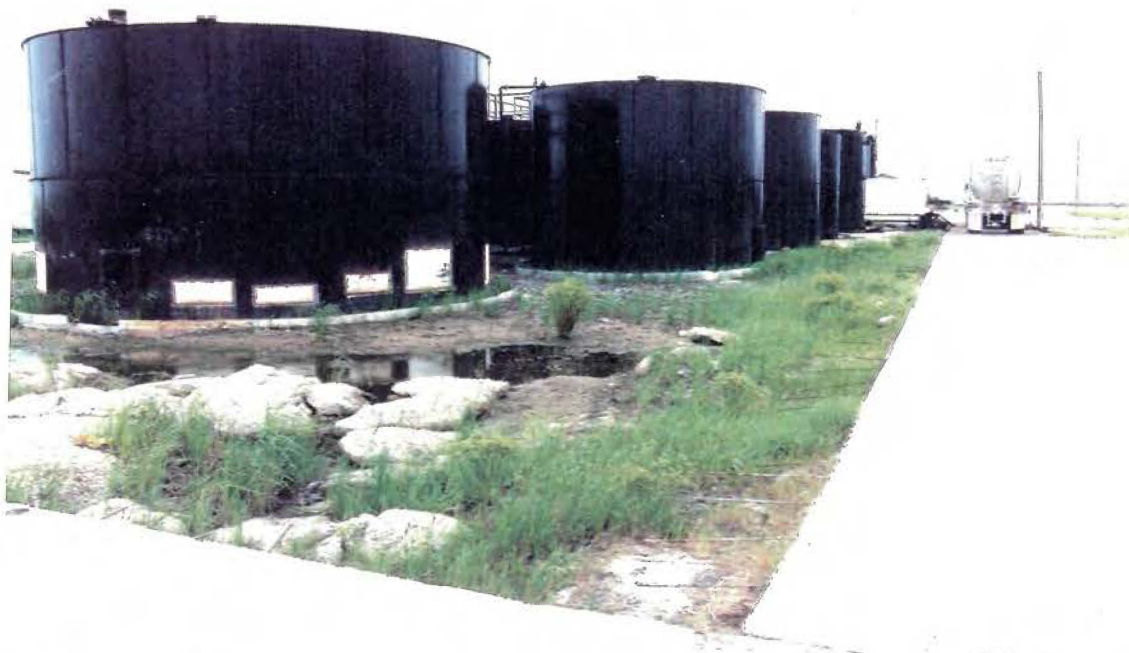
Photograph No. 17

Description: Southwest corner of the AOC No.1; a tank truck is unloading at the north loading area (SWMU No. 4).

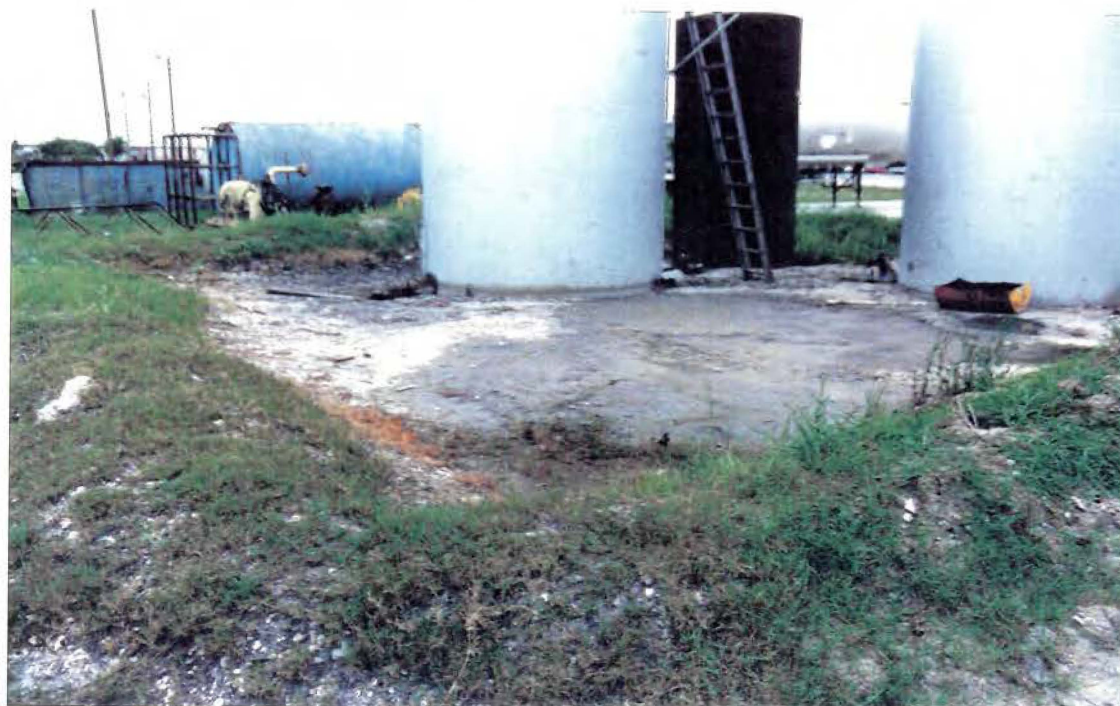
Photograph No. 18

Location: AOC No. 1
